# BRINKLEY RV TROUBLESHOOTING

## TS-HVAC-015 Models Z - Z AIR - I - Ix Furrion Air Conditioner

| <b>TOPIC:</b> | Furrion Air Conditioners | | |

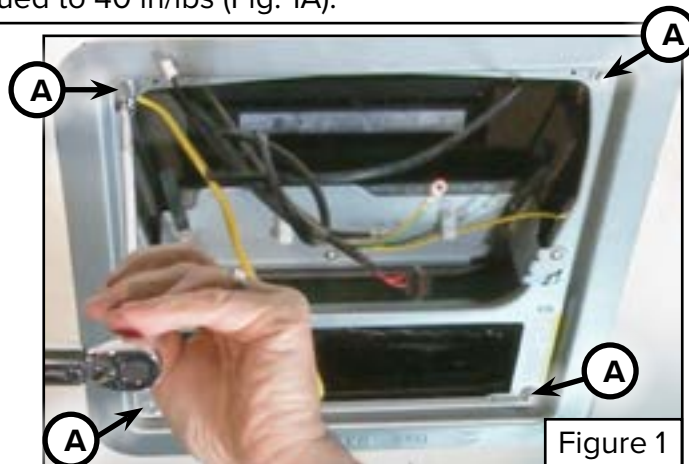
| Root Cause 3: | Mounting bolts are incorrectly torqued. |

| Solution 3: | Remove the Air Distribution Box cover and ensure that the four (4) mounting bolts are torqued to 40 in/lbs (Fig. 1A). |

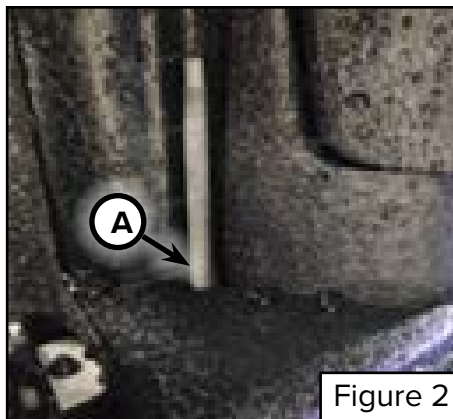
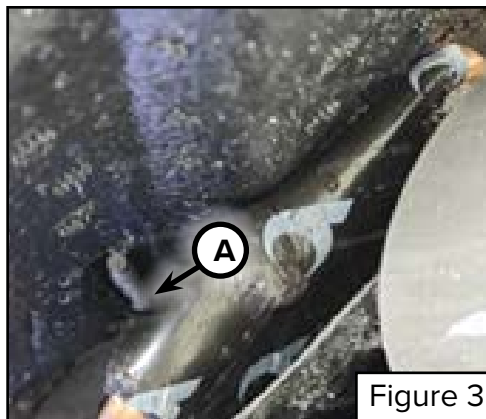
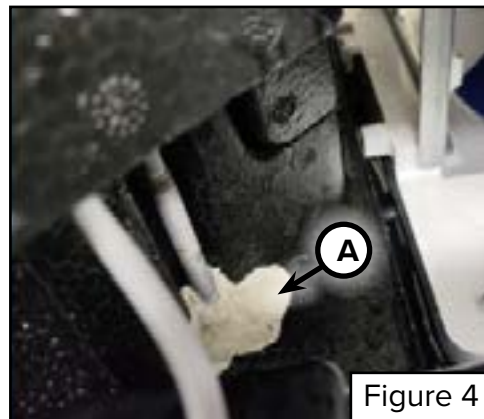
| Root Cause 4: | Water is leaking past the seal on the rear mounting bolts.<br><i>(BRV# 105460 / FACR18VSSA-PS manufactured prior to December 2024 ONLY. Refer to the charts on pages 2 - 4 for your specific unit). In December 2024, a change was made so that the black foam around the evaporator also encapsulates those bolts).</i> |

| Solution 4: | <p><b>To perform this procedure, you will need to climb onto the roof of your unit. Use all appropriate safety equipment and processes for climbing the ladder and for working on an elevated platform, including (but not limited to): non-slip shoes, safety harness, safety glasses, gloves.</b></p> <ol style="list-style-type: none"> <li>1. On the roof of the unit, remove the top shroud of the AC unit.</li> <li>2. Locate the ends of the rear mounting bolts. These are the long bolts used to attach the AC unit and the interior Air Distribution Box together to the roof (see Fig 2A, 3A).</li> <li>3. Apply sealant where the bolts protrude through the black foam. Use butyl putty or RV Caulk sealant (see Fig. 4A).</li> <li>4. Reinstall the top shroud of the AC unit.</li> </ol> |

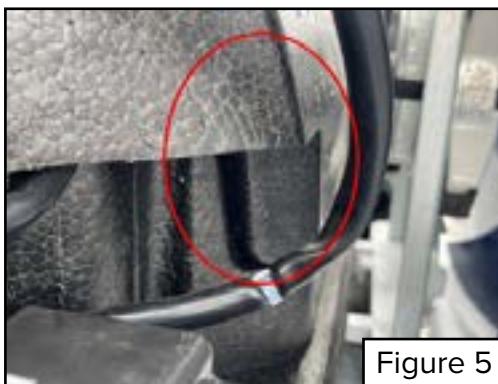
Figure 5

| Root Cause 5: | Evaporator foam is not completely mating up, causing a small gap.<br><i>(BRV# 105460 / FACR18VSSA-PS manufactured prior to December 2024 ONLY. Refer to the charts on pages 2 - 4 for your specific unit).<br/>In December 2024, a change was made to the black foam around the evaporator.</i> |

| Solution 5: | <p><b>To perform this procedure, you will need to climb onto the roof of your unit. Use all appropriate safety equipment and processes for climbing the ladder and for working on an elevated platform, including (but not limited to): non-slip shoes, safety harness, safety glasses, gloves.</b></p> <ol style="list-style-type: none"> <li>1. On the roof of the unit, remove the top shroud of the AC unit.</li> <li>2. Inspect the rear right corner (facing front of unit) of the mating top and bottom evaporator housing (see Fig. 5).</li> <li>3. If it appears to be bulging out, it is possible that a small gap exists. This gap could be just wide enough for strong wind to blow a small amount of water through the housing gap.</li> <li>4. Apply caulk tape to the corners to ensure a good seal (see Fig. 6) and reassemble.</li> </ol> |
